**COMMONWEALTH OF VIRGINIA
STATE CORPORATION COMMISSION
DIVISION OF PUBLIC UTILITY REGULATION**

**PREPARATION FOR AND RESPONSE TO
FEBRUARY 2021 ICE STORM**

**SPECIAL REPORT OF THE DIVISION OF
PUBLIC UTILITY REGULATION**

September 16, 2021

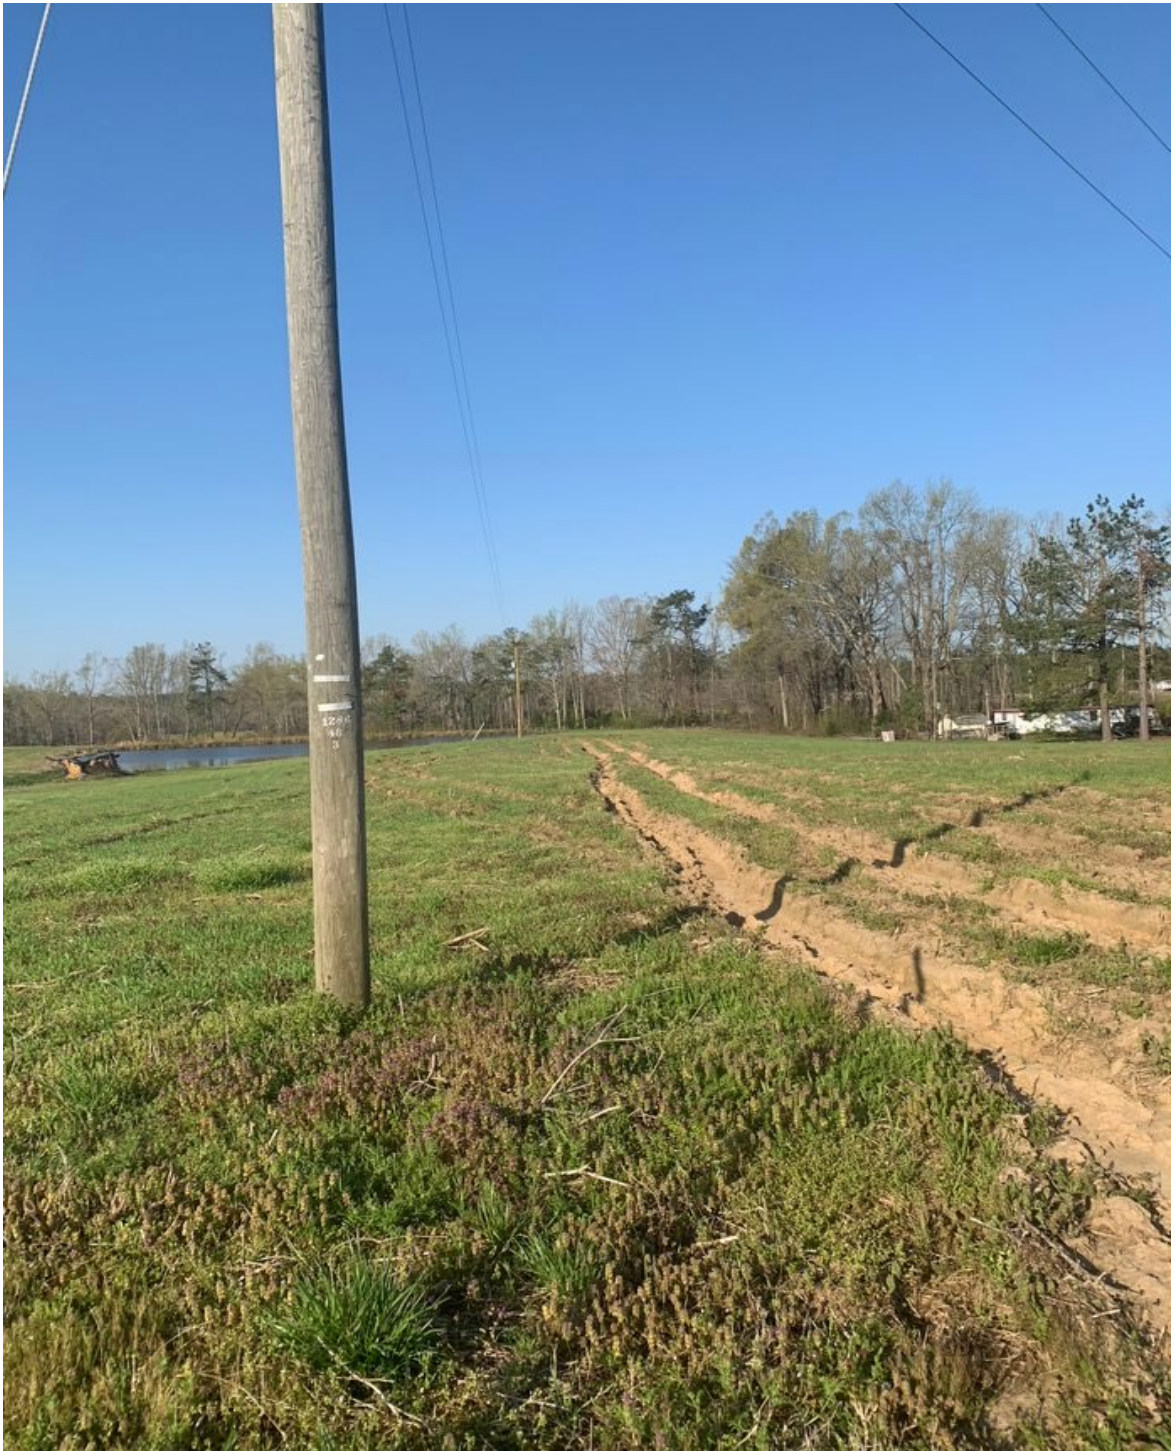
damage locations to effect repair. Southside acknowledges that during severe storms, the use of tracked vehicles is the most effective way to access many locations within its service territory; however, SEC reports that it owns only one such vehicle. Southside stated it has access to tracked vehicles through mutual aid agreements, but that depending on storm location and severity, the availability of such vehicles through mutual aid can be greatly diminished.

Figure 8. An Area Where A Tracked Vehicle Was Needed

While Staff realizes that it can be costly for a cooperative to own tracked vehicles, Staff believes that during major storms, these vehicles can significantly reduce restoration times by allowing repair materials and personnel to reach locations that are difficult to access. For example, the photographs in Figures 8 and 9 below, taken by Staff during a post-Storm visit, show some areas in SEC's service territory that were difficult to access during the Storm because of their remote locations and because of deep mud created by melting ice. Accordingly, the need for tracked vehicles for storm restoration is amplified by the nature of the terrain in SEC's service territory. SEC advised that it is planning to investigate adding more tracked vehicles to its fleet in 2022. Staff supports such an analysis.

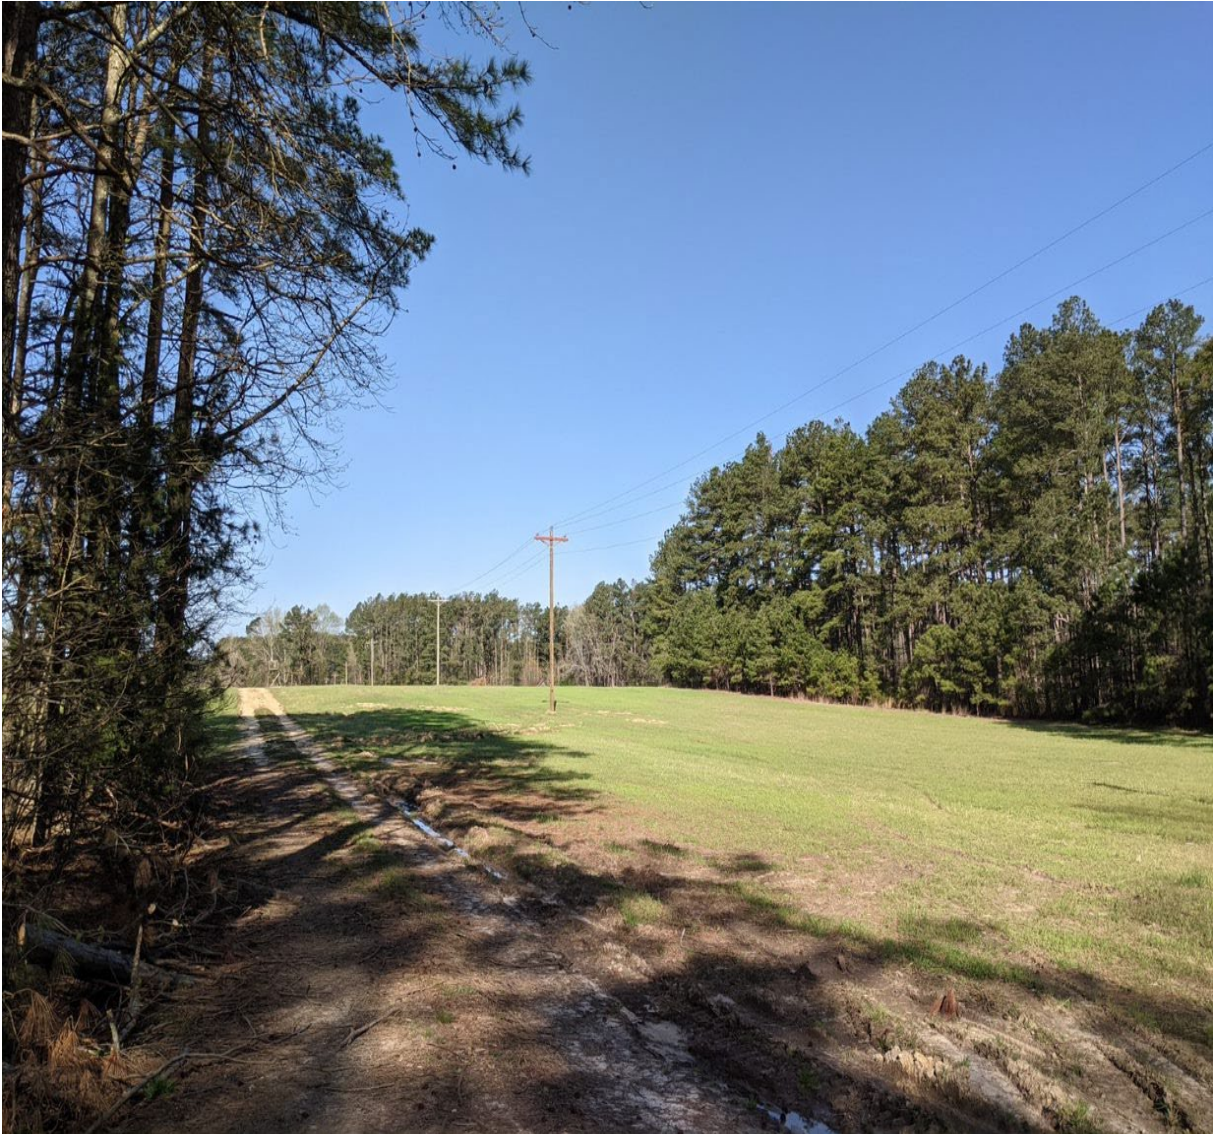
Figure 9. An Additional Area Where a Tracked Vehicle Was Needed

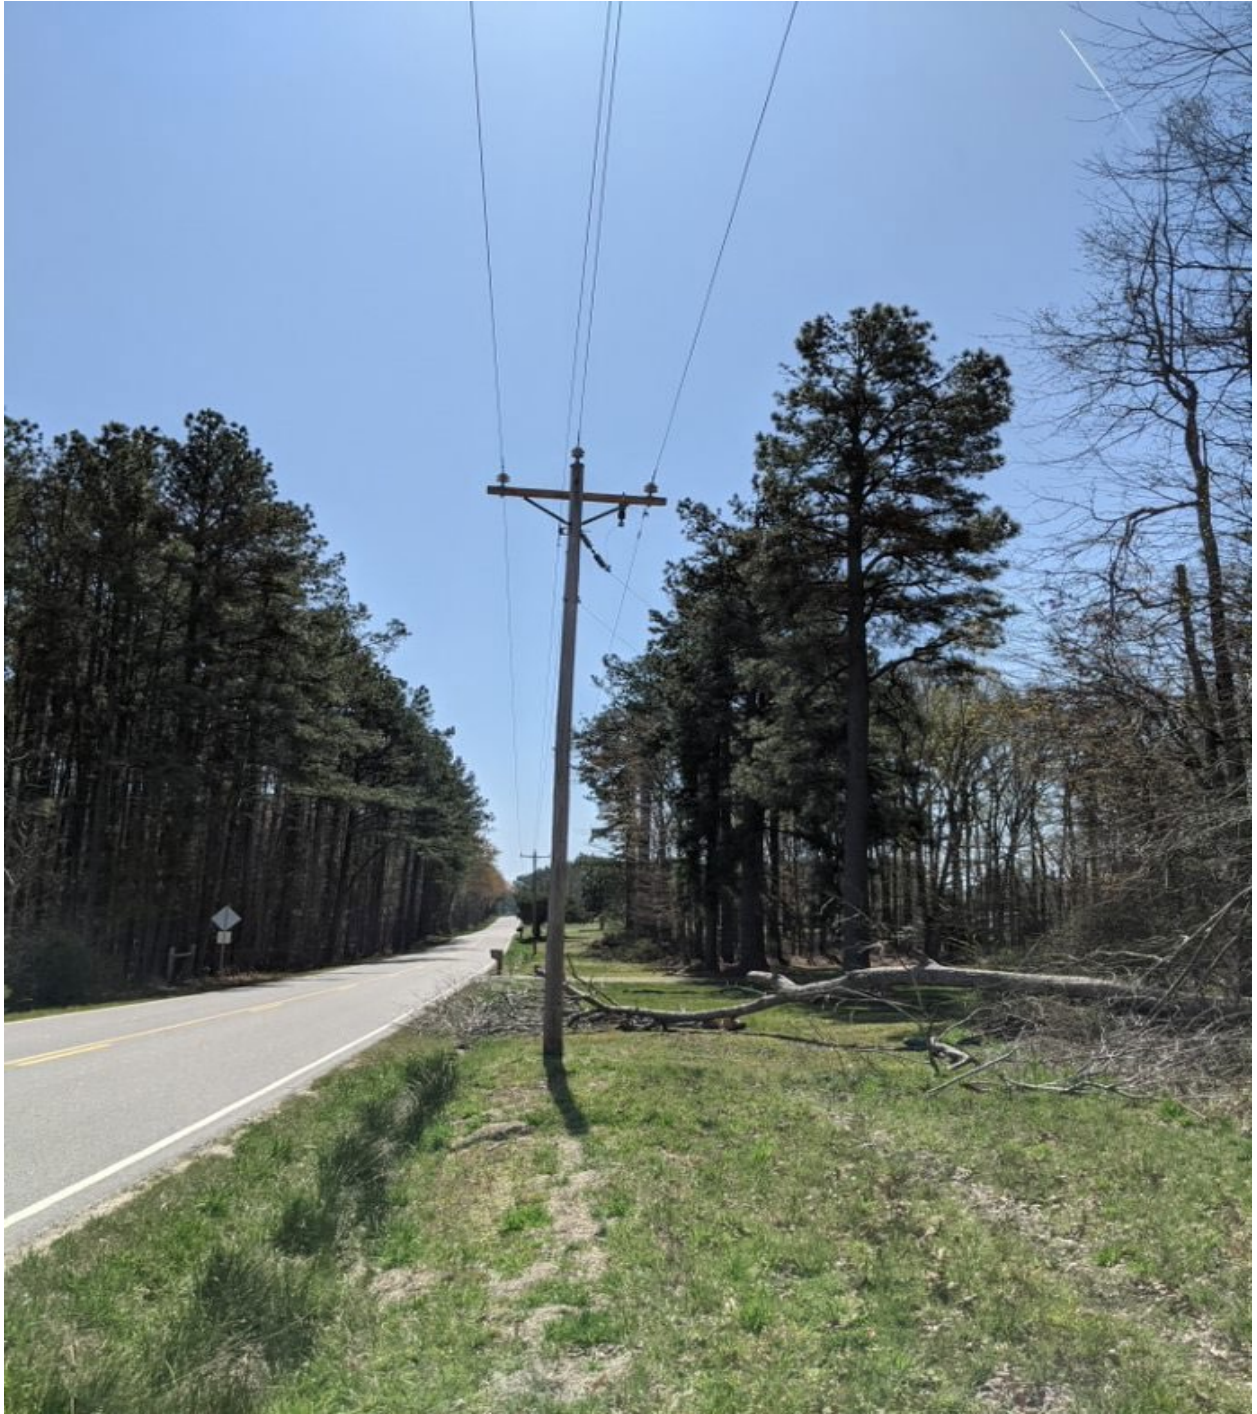
The following pictures, taken by Staff during a post-Storm visit to Southside's service territory, provide some examples of hazard trees that Staff identified. In Figures 10 and 11, the hazard tree was dead before the Storm occurred (even though it still remained upright before the Storm), thereby increasing its likelihood of falling across the distribution infrastructure during the Storm conditions.

Figure 10. Hazard Tree Example

Hazard tree removal is performed on an approximate three to four year cycle and focuses on off-cycle tree removals identified by Cooperative members, operations personnel, utility foresters, and various system and vegetation patrols. Assuming expected performance, a hazard tree patrol would be scheduled along a feeder in years three or four following the last side-trimming activity. A Davey Resources vegetation audit from December 2015²³ estimated that SEC had approximately 6,500 hazard trees needing mitigation. Most of those were located in the Central District where the Ice Storm was centered. In its report, Davey Resources recommended that SEC inspect all 3-phase lines bi-annually or annually. Staff recommends that SEC give serious consideration to Davey

Resources' guidance to alleviate the danger to distribution infrastructure posed by hazard trees.

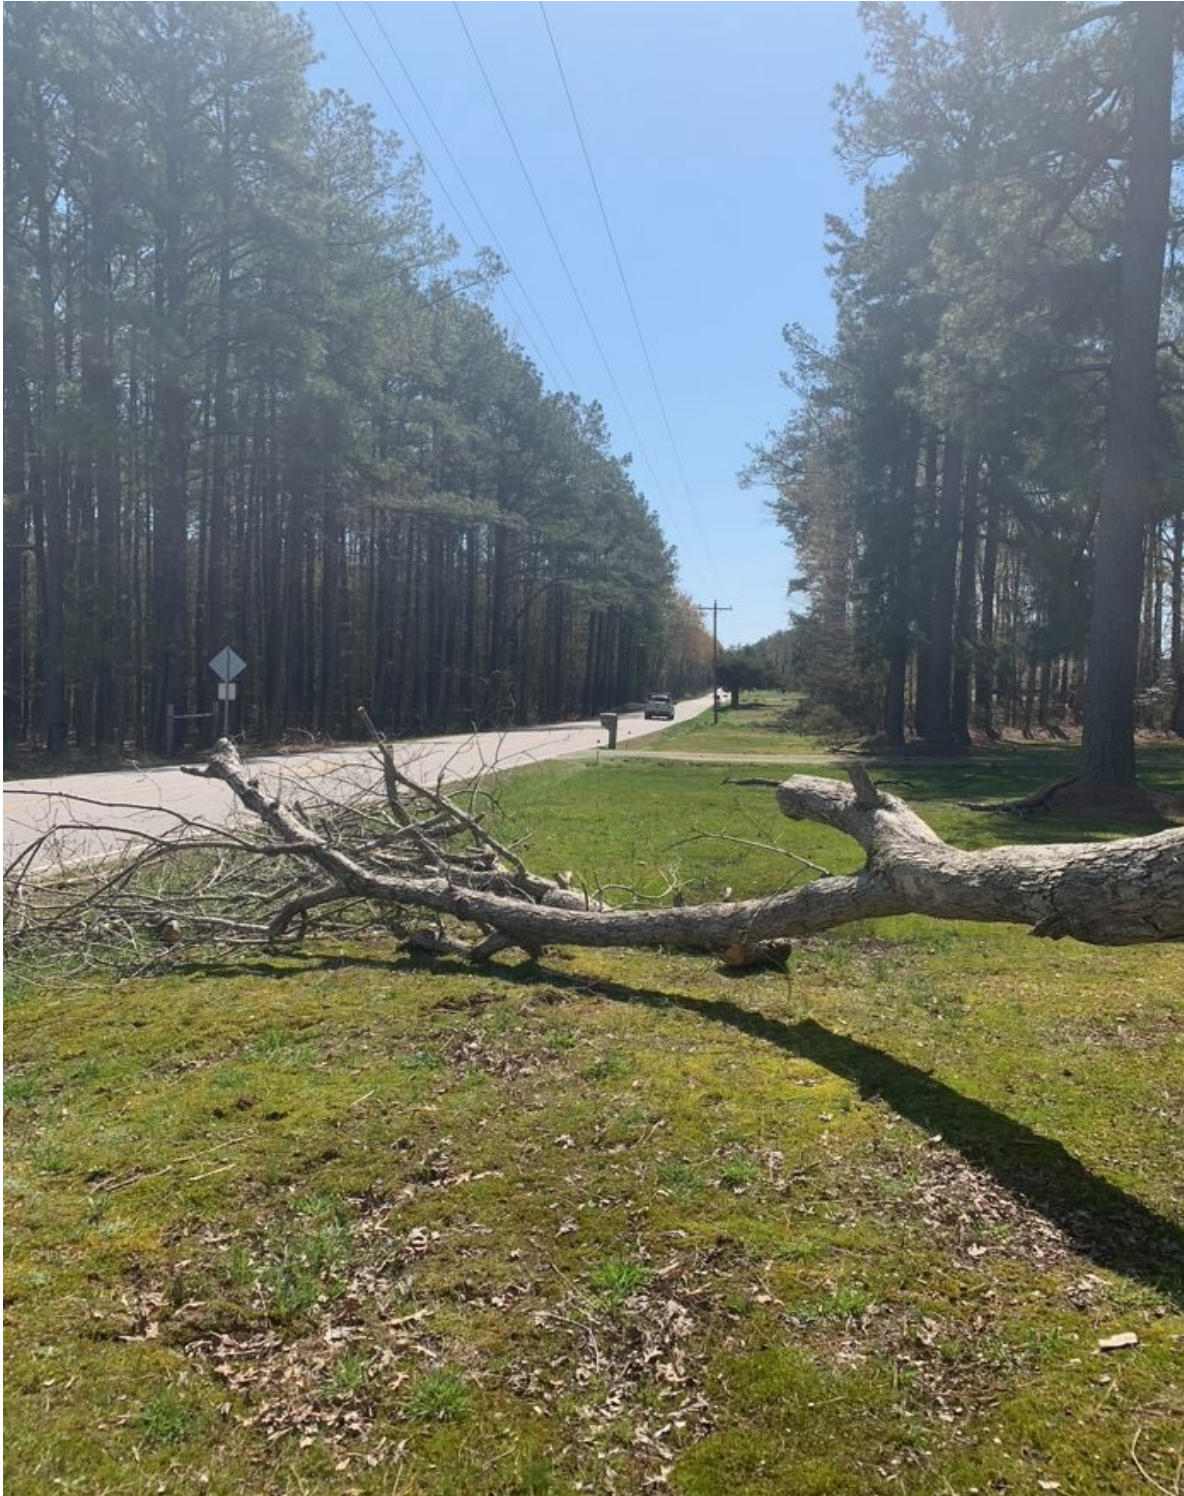
Figure 11. Hazard Tree Example

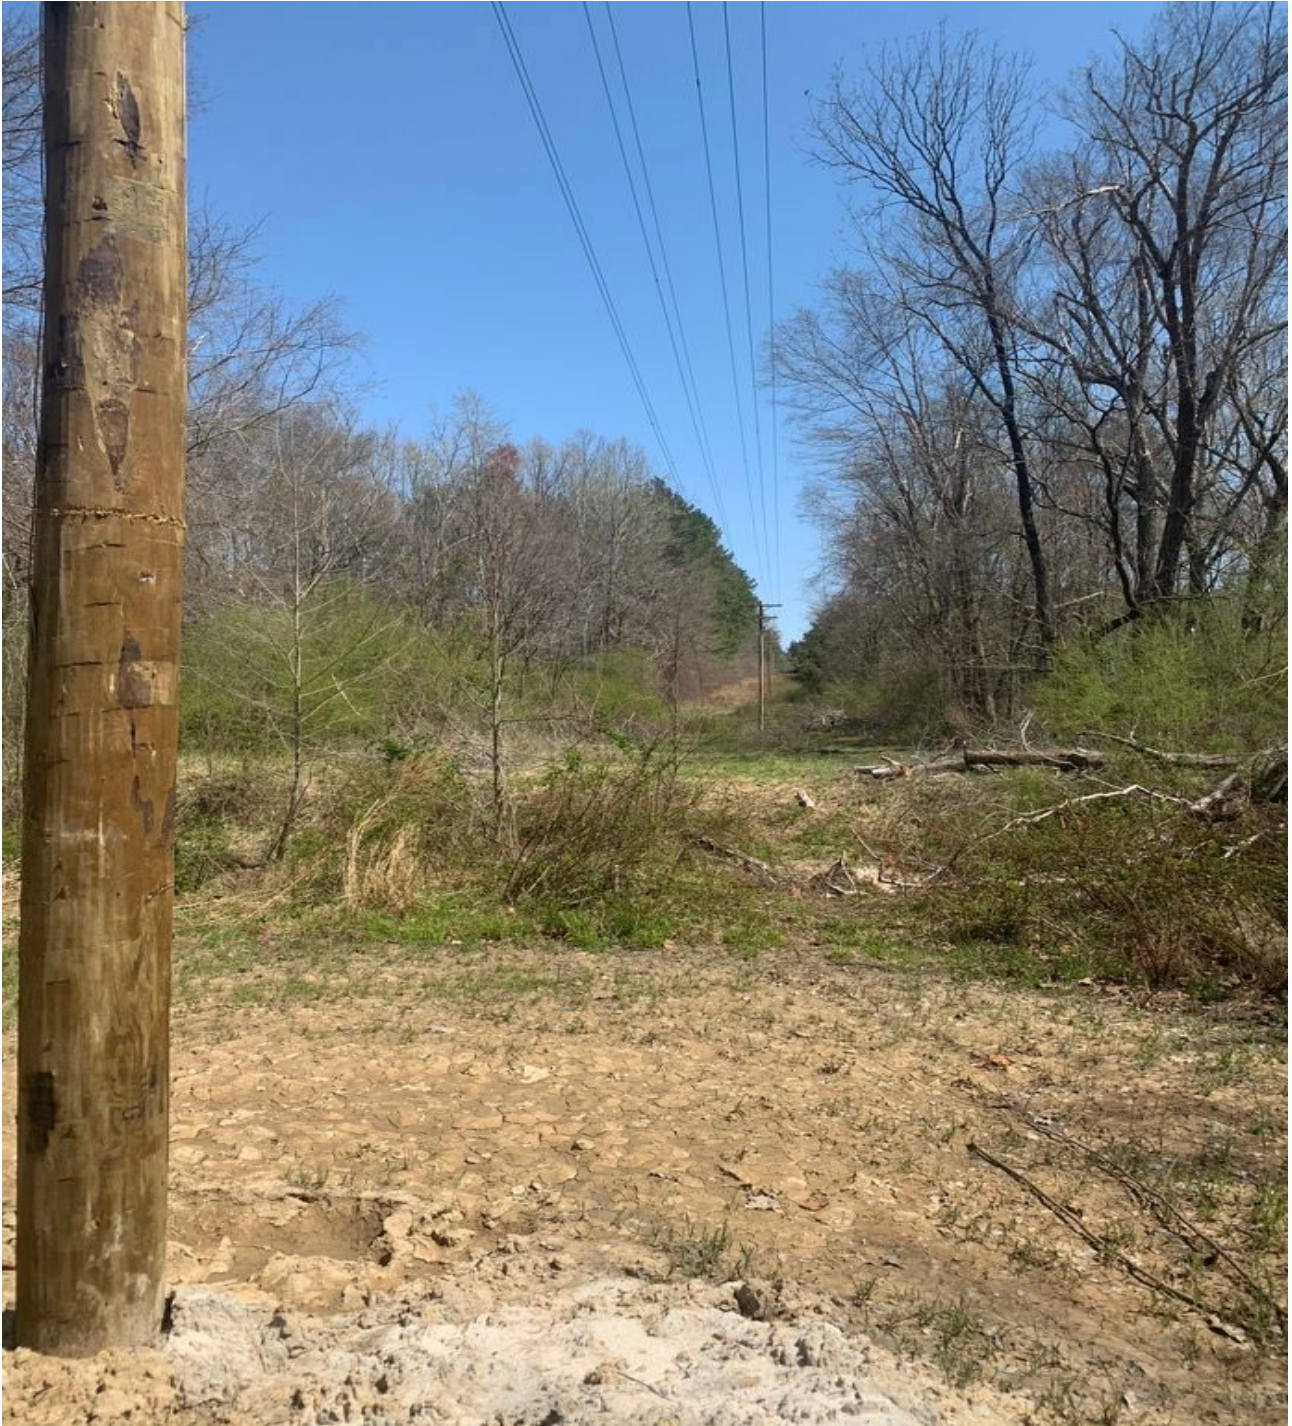
Figure 12. Hazard Trees along and in the ROW

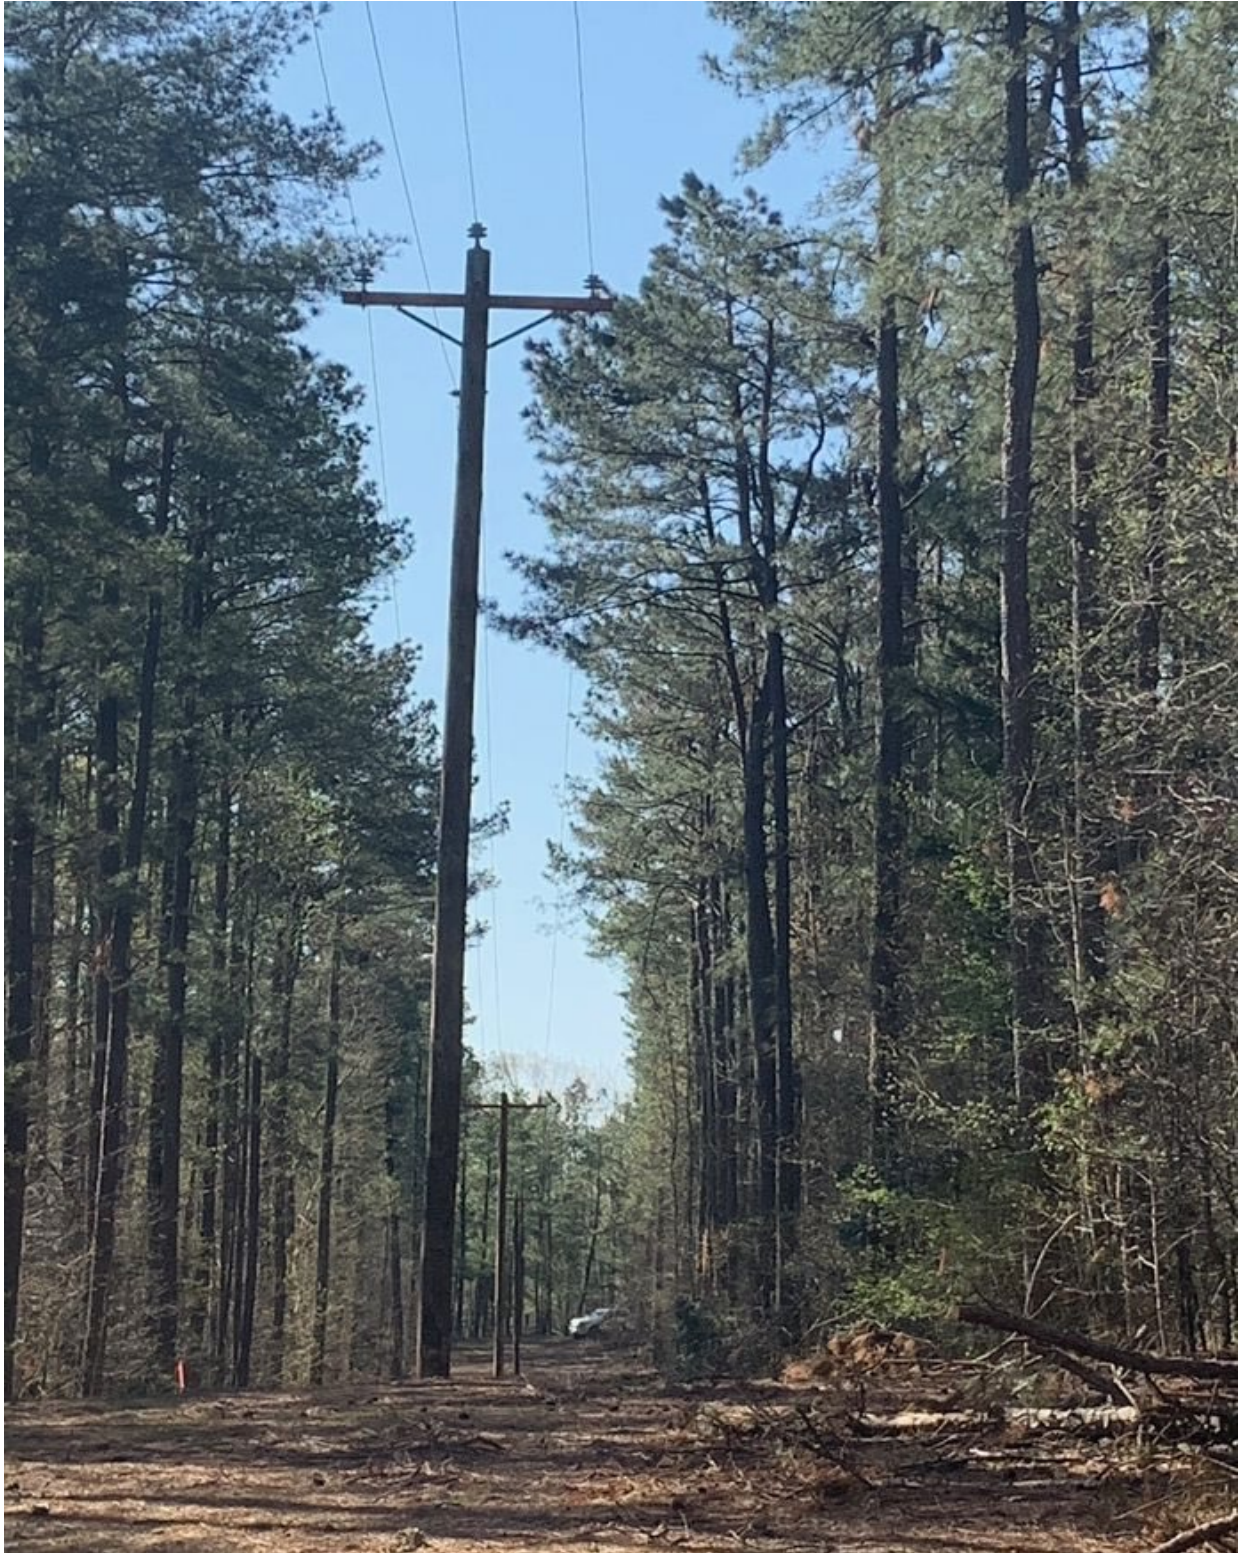
Southside notes that ten circuits trimmed in the 2020 and 2021 timeframe still experienced outages from tree damage caused by the Ice Storm. As a result, SEC maintains that the date of last side-trim does not necessarily provide an accurate reflection as to which circuits performed well during the Ice Storm. SEC believes that side-trimming would not have eliminated the damage caused since 95.8% of outages for the Ice Storm were reportedly caused by trees located outside the maintained ROW and were not hazard trees. During its visit to SEC's service territory, Staff observed that many of the areas that were already cleared and rebuilt from the Ice Storm still had overhanging branches from trees

located outside the ROW. Some examples of such locations are provided in the photographs shown in Figures 13-15 below that were taken during Staff's post-Storm visit to SEC's service territory. Based on these observations, Staff recommends that Southside revise its side trimming program to include ground-to-sky trimming to mitigate outages caused by limbs on outside-ROW-located trees breaking over conductors.

Figure 13. Limbs Overhanging Previously Cleared ROW

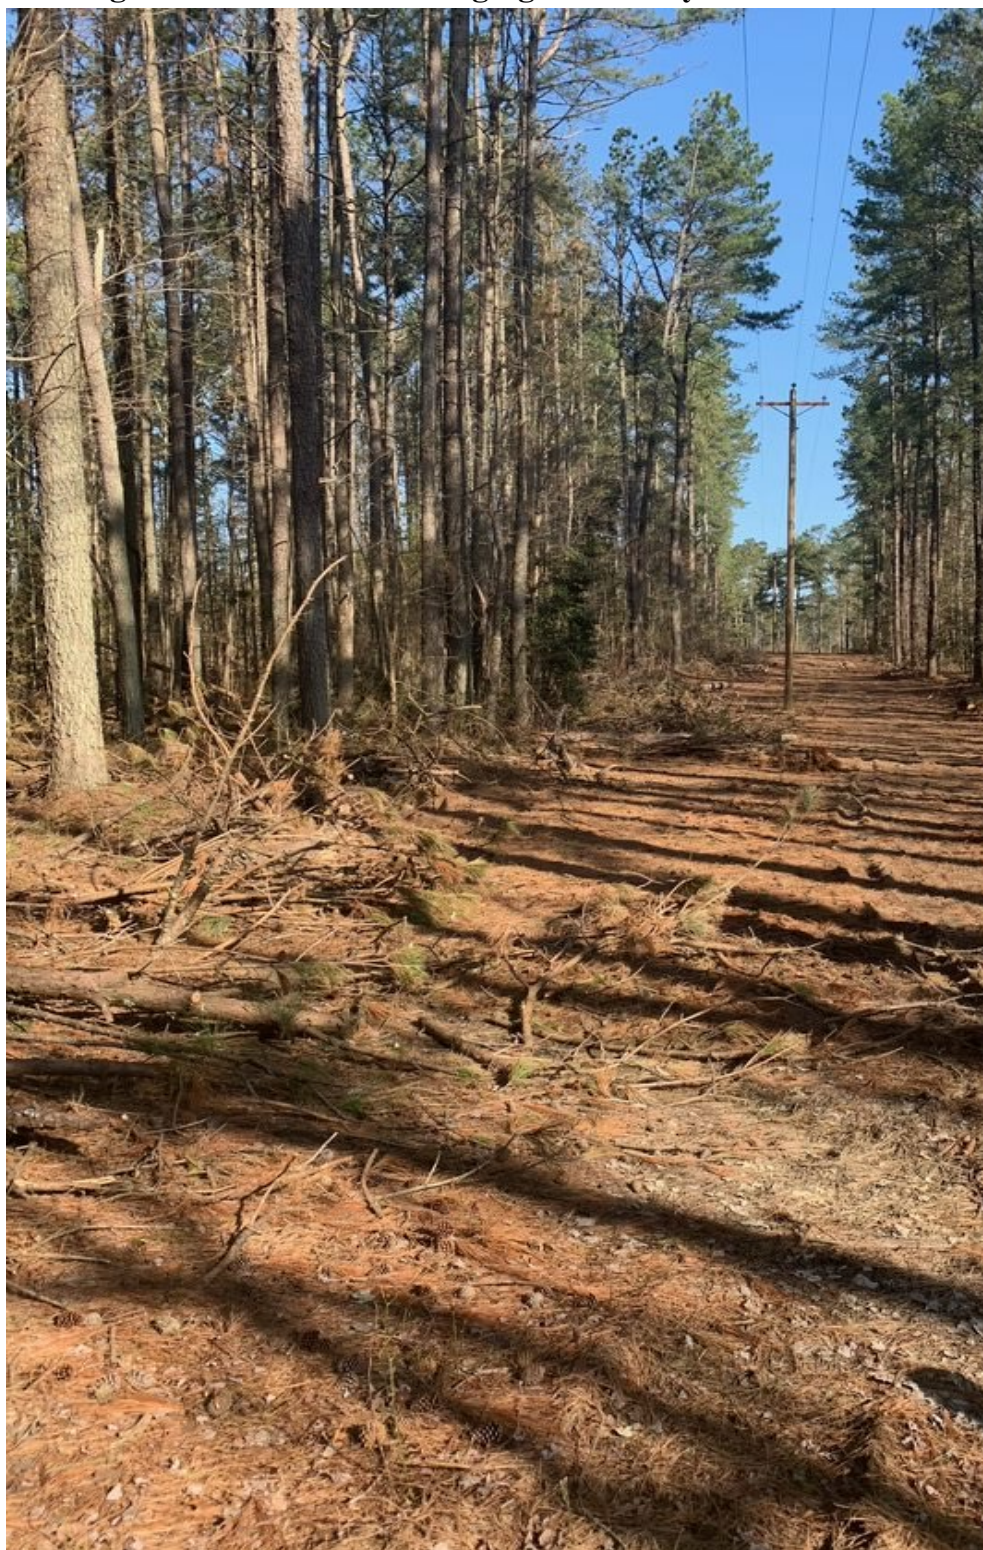
Figure 14. Limbs Overhanging Previously Cleared ROW

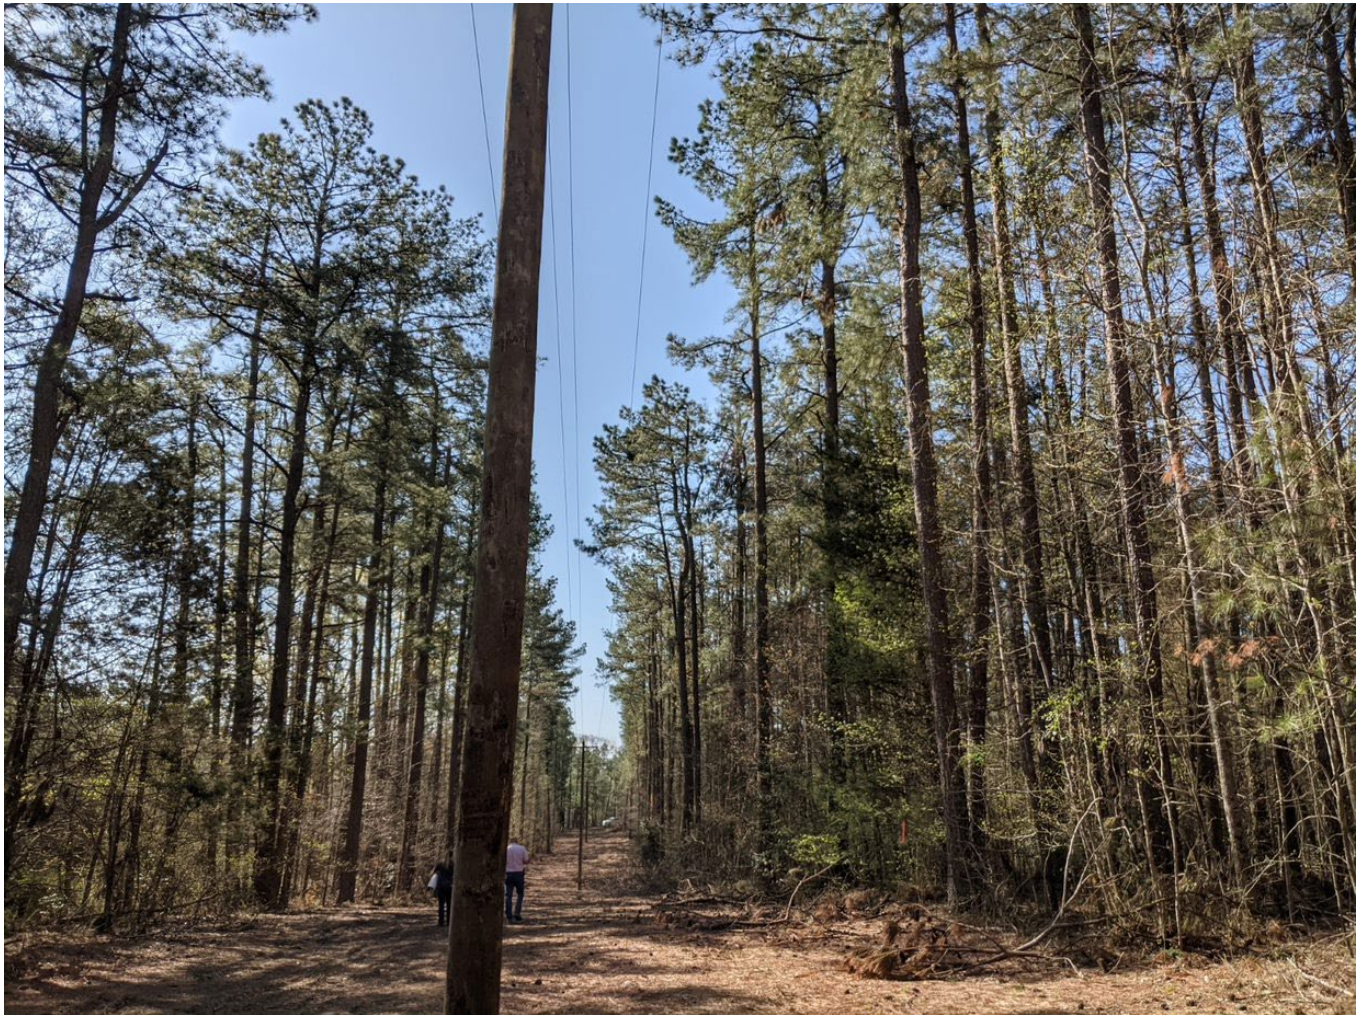
Figure 15. Limbs Overhanging Previously Cleared ROW

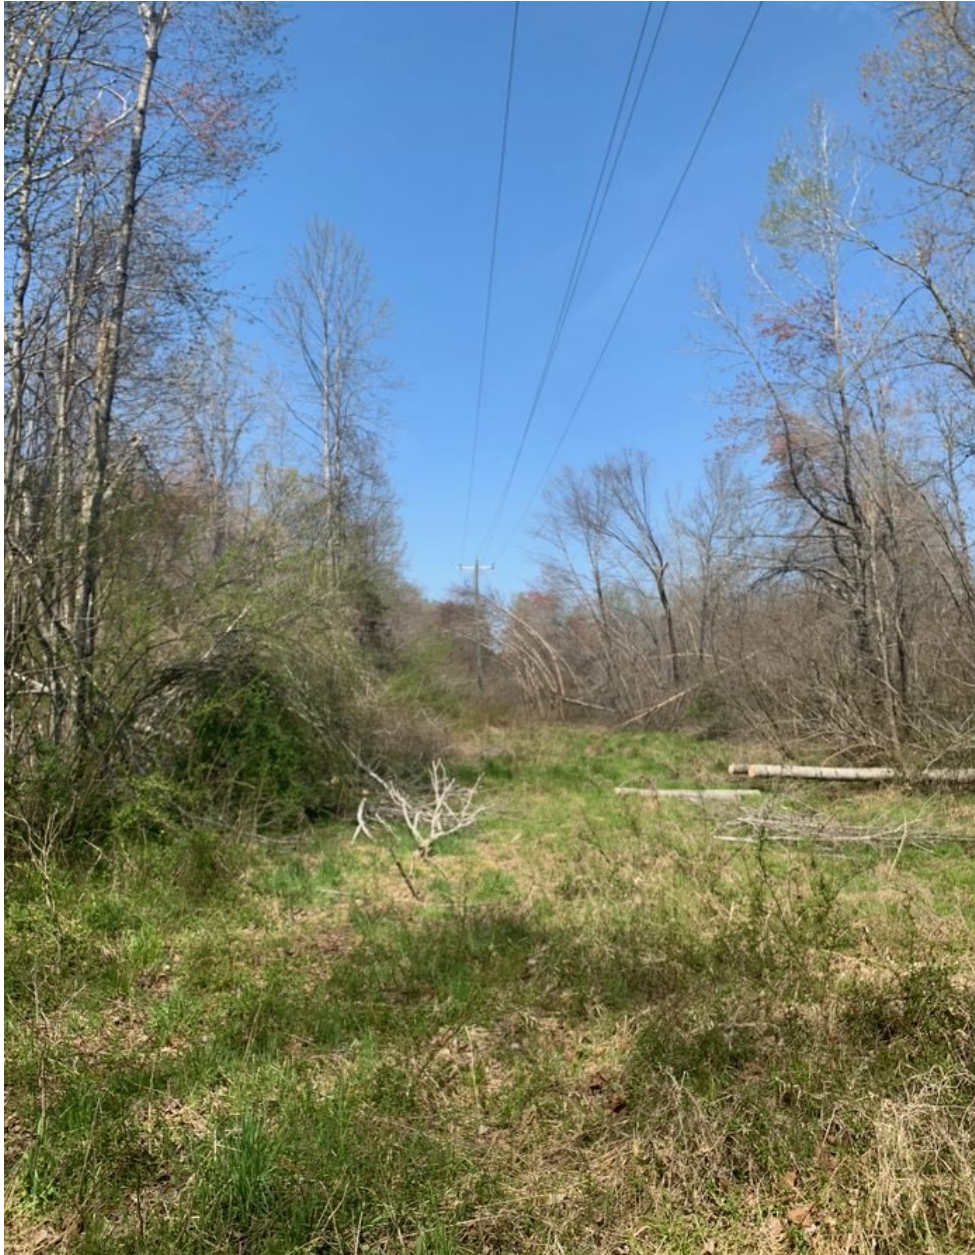
As previously mentioned, Southside performs side trimming on a seven-year cycle; however, this pace appears inadequate to stay ahead of new growth on SEC's system. Staff recommends that SEC accelerate this schedule along with increased brush clearing and the use of herbicide. In support of this recommendation, Staff notes its observation during the aforementioned post-Storm visit: one particular location was significantly overgrown with brush and appeared not to have been maintained for an extended period of time (See Figure 16 and 17).

Figure 16. Example of Densely Overgrown ROW

Staff is concerned that overgrowth such as this may not be uncommon, and that SEC's current trimming cycle appears to be more reactive than proactive relative to tree trimming and hazard tree removal. According to SEC, the last vegetation management audit was performed in December 2015 by Davey Resources. That audit noted that many aspects of SEC's tree trimming, hazard tree, and herbicide programs needed improvement. Unfortunately, Staff's inspection of multiple outage locations revealed that the recommendations from Davey Resources had not been implemented six years later. Staff

recommends that the Cooperative perform a vegetation audit every 5 years and adhere to the recommendations included in the Davey Resources audit, providing such can be accomplished at a reasonable cost, in order to get the maximum benefit from this effort and to ultimately improve service reliability to its members.

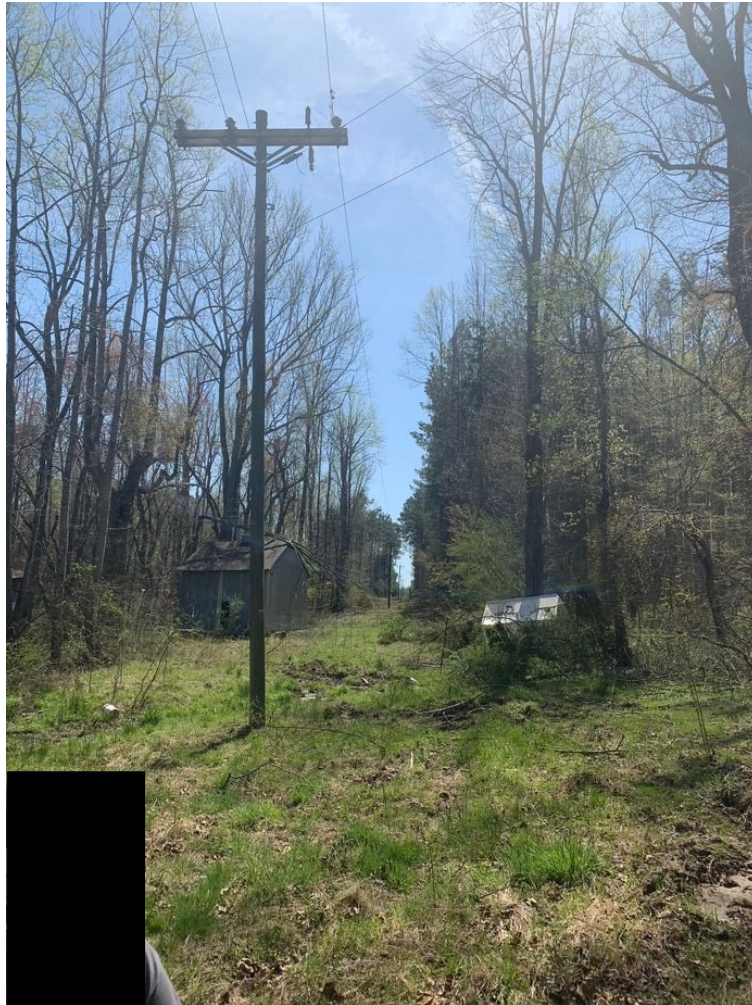
Figure 17. Overgrown ROW

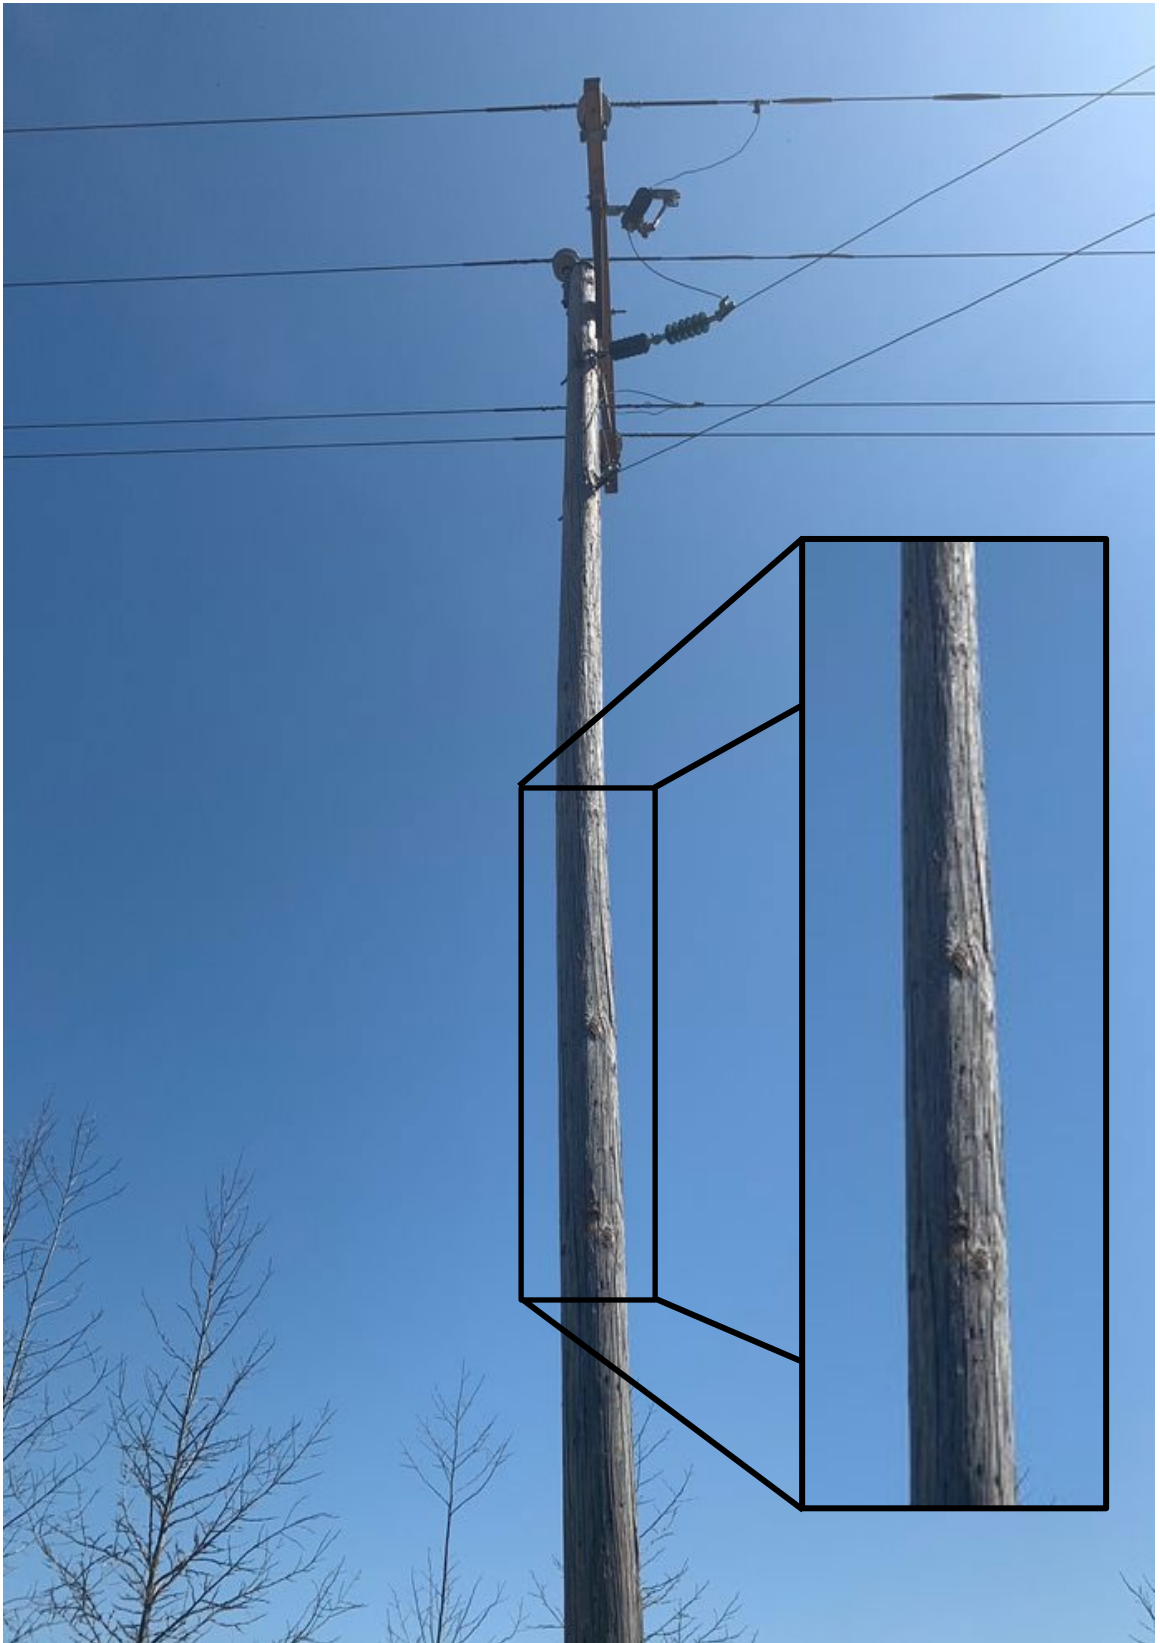
As previously noted, SEC indicates that no poles were overdue for replacement prior to the Storm and that 3.7% of poles broken during the Storm were known rejects from the 2020 Pole Inspection and Treatment program. During Staff's post-Storm field visit to SEC, Staff observed poles in several locations that appeared to require replacement. For example, Staff observed poles with shell-rot, cracks, and wildlife damage (see photograph in Figure 19 below). Staff concludes that SEC's Pole Inspection and Treatment Program is not keeping pace with the aging infrastructure. As such, Staff recommends that SEC consider reviewing and possibly modifying criteria for pole rejection as well as accelerating pole inspections and replacement of rejected poles.

Figure 19. Pole with Wildlife Damage and Shellrot

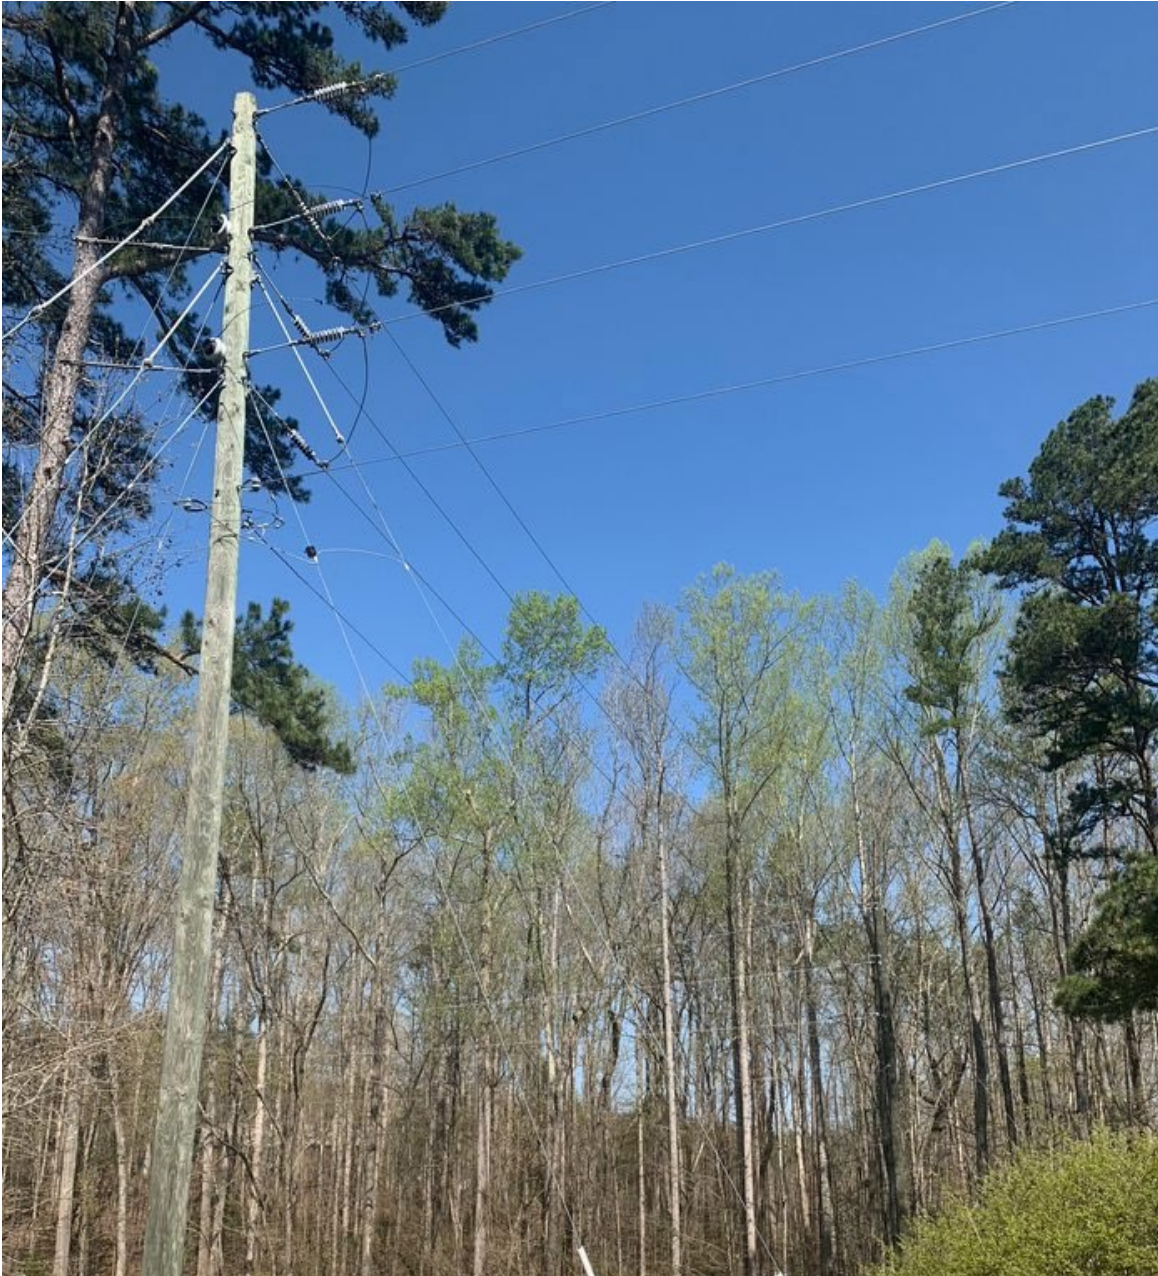
Based on Staff's inspection of the repaired sections, it appeared that some conductors observed were under an unusually high tension. Some examples of those are provided in the photographs shown in Figures 20 and 21.

Figure 20. Corner Pole with High Tension

While this was a visual observation, Staff brings it to the attention of SEC for future investigation to verify compliance with RUS standards. Where appropriate, SEC should consider using shorter span lengths to maintain required safety clearances while alleviating the need for higher tension on conductors.

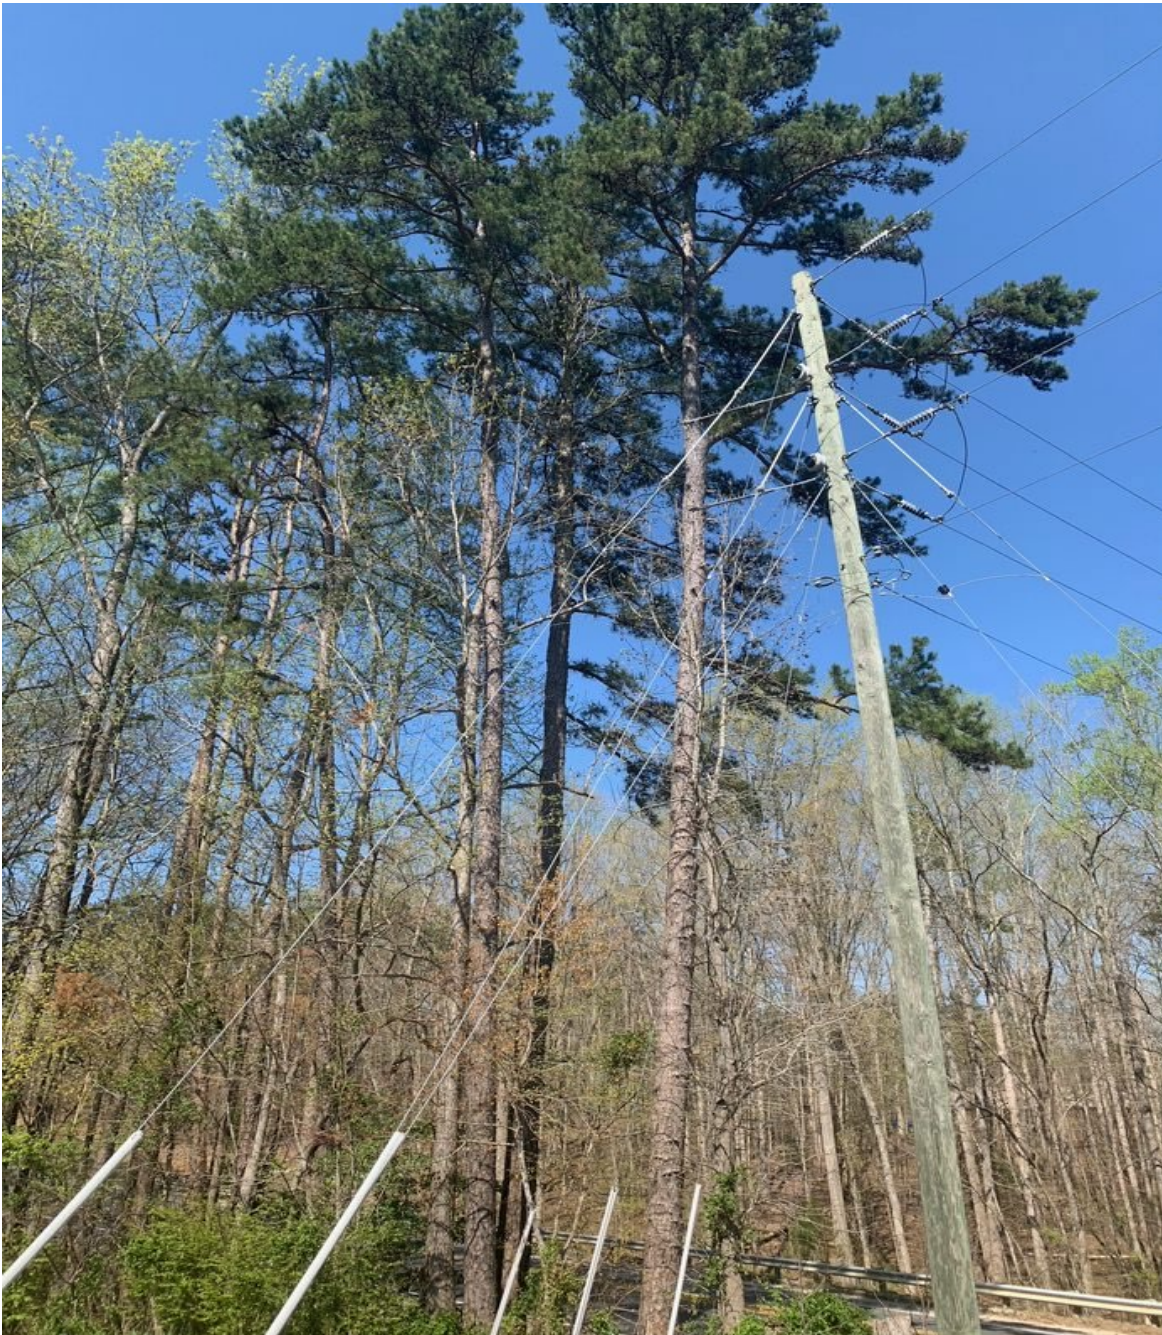
Figure 21. Corner Pole with High Tension
