**COMMONWEALTH OF VIRGINIA  
STATE CORPORATION COMMISSION  
DIVISION OF PUBLIC UTILITY REGULATION**

**UTILITY PREPARATION FOR AND RESPONSE TO  
JANUARY 2022 WINTER STORM "FRIDA"**

**SPECIAL REPORT OF THE DIVISION OF  
PUBLIC UTILITY REGULATION**

October 14, 2022

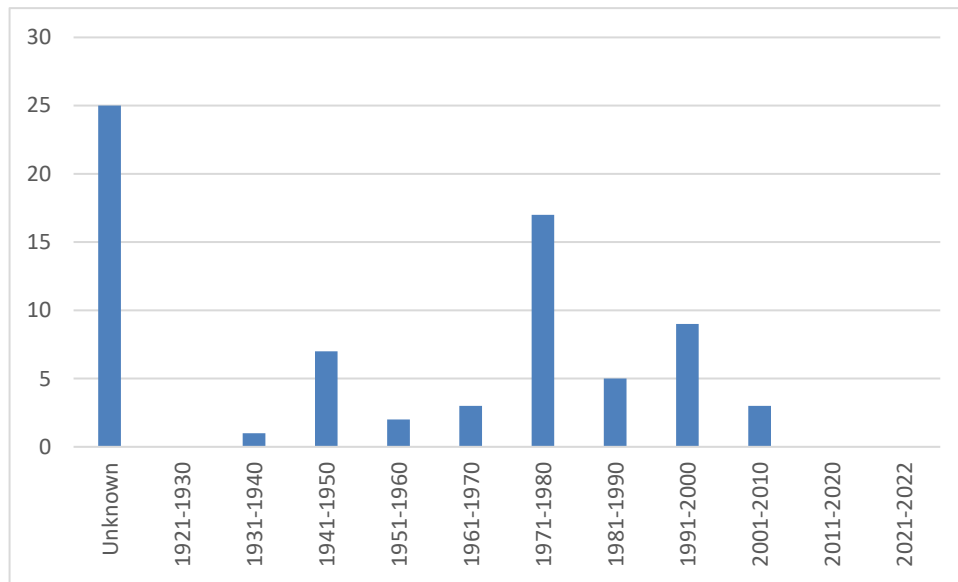
**Figure 10. APCo Poles Replaced During Storm by Vintage**

number and vintage of poles replaced as a result of Winter Storm Frida. The company states that this data suggests that age and condition of the poles were not a significant factor in the storm due to the prevalence of failures of relatively newer poles.

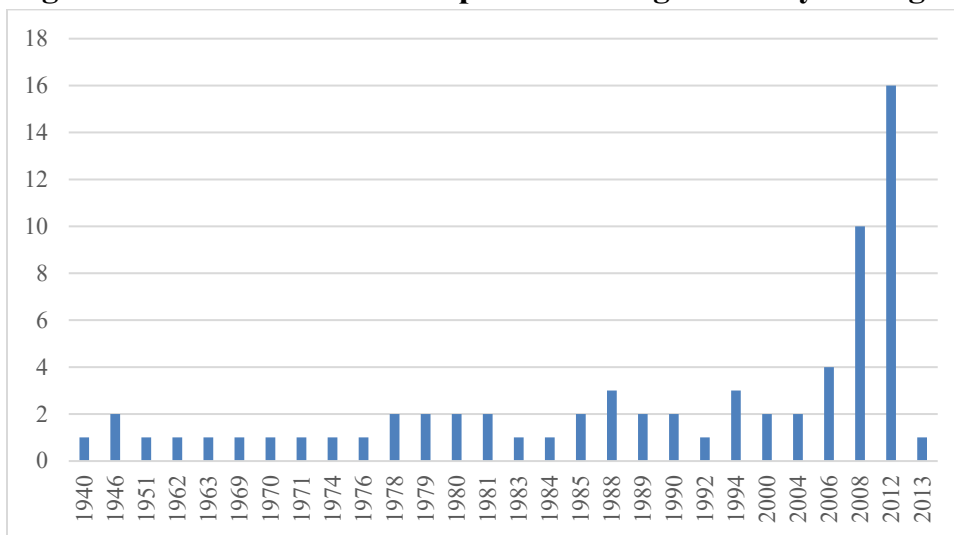
**Figure 11. Dominion Poles Replaced During Storm by Vintage<sup>15</sup>**

Figure 11 below depicts the number and vintage of poles replaced as a result of Winter Storm Frida. This data suggests that age and condition of the poles was not a significant factor in the storm due to the prevalence of failures of relatively newer poles.

<sup>15</sup> In addition to the poles included in this chart, Dominion states that of the 366 poles replaced as a result of damage during the Storm, the vintage (or birth year) of 297 additional poles is unknown.

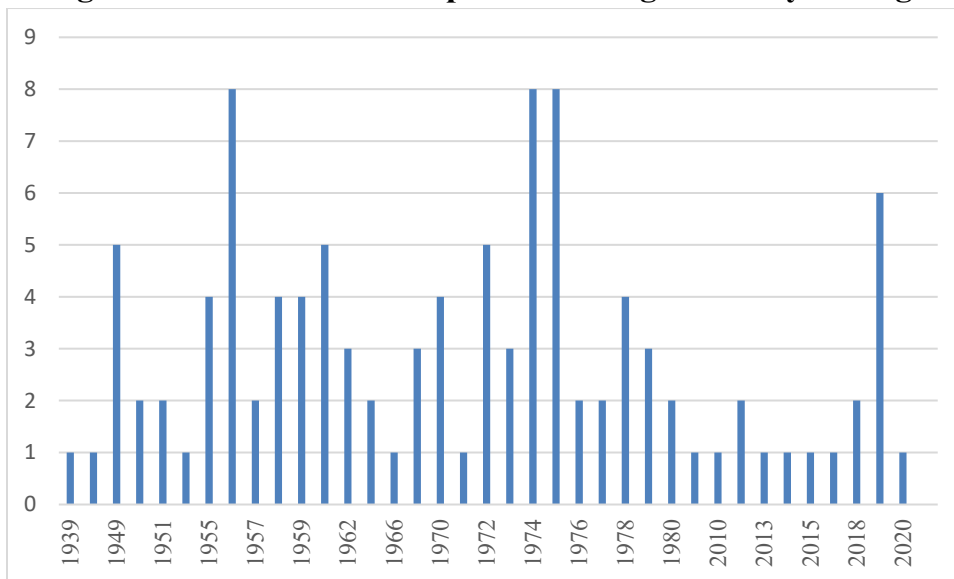
**Figure 12. CVEC Poles Replaced During Storm by Vintage**

Figure 12 below depicts the number and vintage of poles replaced as a result of the Storm. This data suggests that age and condition of the poles was not a significant factor in replacement during the storm.
