**COMMONWEALTH OF VIRGINIA
STATE CORPORATION COMMISSION
DIVISION OF PUBLIC UTILITY REGULATION**

**PREPARATION FOR AND RESPONSE TO
FEBRUARY 2021 ICE STORM**

**SPECIAL REPORT OF THE DIVISION OF
PUBLIC UTILITY REGULATION**

September 16, 2021

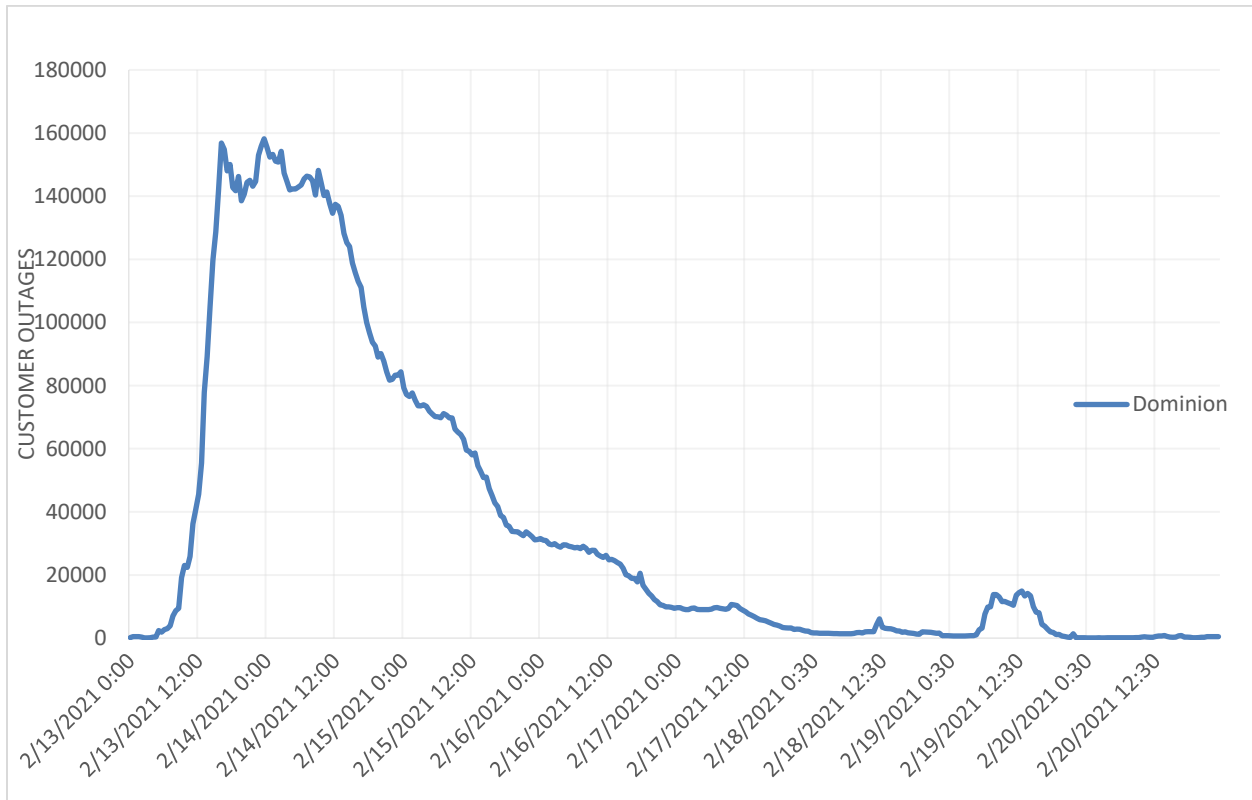
Figure 5. Dominion Ice Storm Restoration Curve

The restoration effort lasted 6.75 days for the Central Region, 1.46 days for the Eastern Region, and 1.50 days for the Northwest Region. Dominion reported 325 broken poles; 875 broken cross-arms; and 577,000 conductor feet restrung for a total of 11,004

According to DEV, there were 2,619 outages caused by trees. This represents 54% of the 4,823 total outage events across Dominion's Virginia and North Carolina service territory. DEV does not collect data relative to whether tree-related outages are caused by trees located within the ROW or outside the ROW.

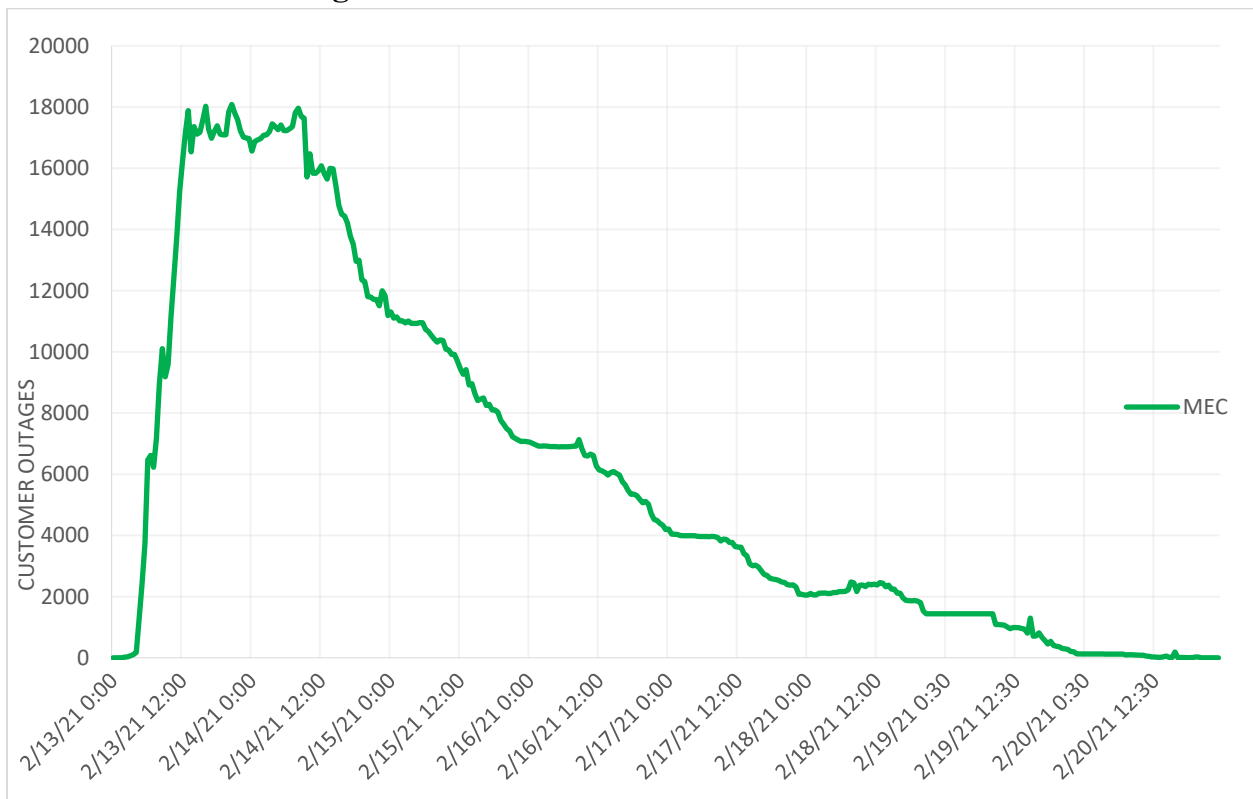
Figure 6. MEC Ice Storm Restoration Curve

MEC reported 169 broken poles and 18 broken cross-arms; there were also multiple locations where cable splices were required. Mecklenburg advised that restringing of conductor was seldom necessary since the conductors at most locations could be spliced, repaired, and returned to service. Of the 939 total outages on the system, MEC states that 883 outages, or approximately 95%, were caused by trees outside of the ROW.

failures, downed trees, and broken limbs. MEC advised that the severity of the damage in northern Halifax and Pittsylvania Counties was worse than expected. MEC states it immediately recognized that storm restoration would be hampered by the large numbers of damaged and downed trees. Mecklenburg noted that downed trees were primarily located outside both its 30-foot-wide single-phase and its 50-foot-wide three-phase ROWs. MEC also reported that saturated ground conditions made access to many facilities initially impossible and that some were inaccessible for days. After initial assessments were conducted and areas of significant damage identified, Mecklenburg determined that the Storm had damaged or affected over 65% of its system.

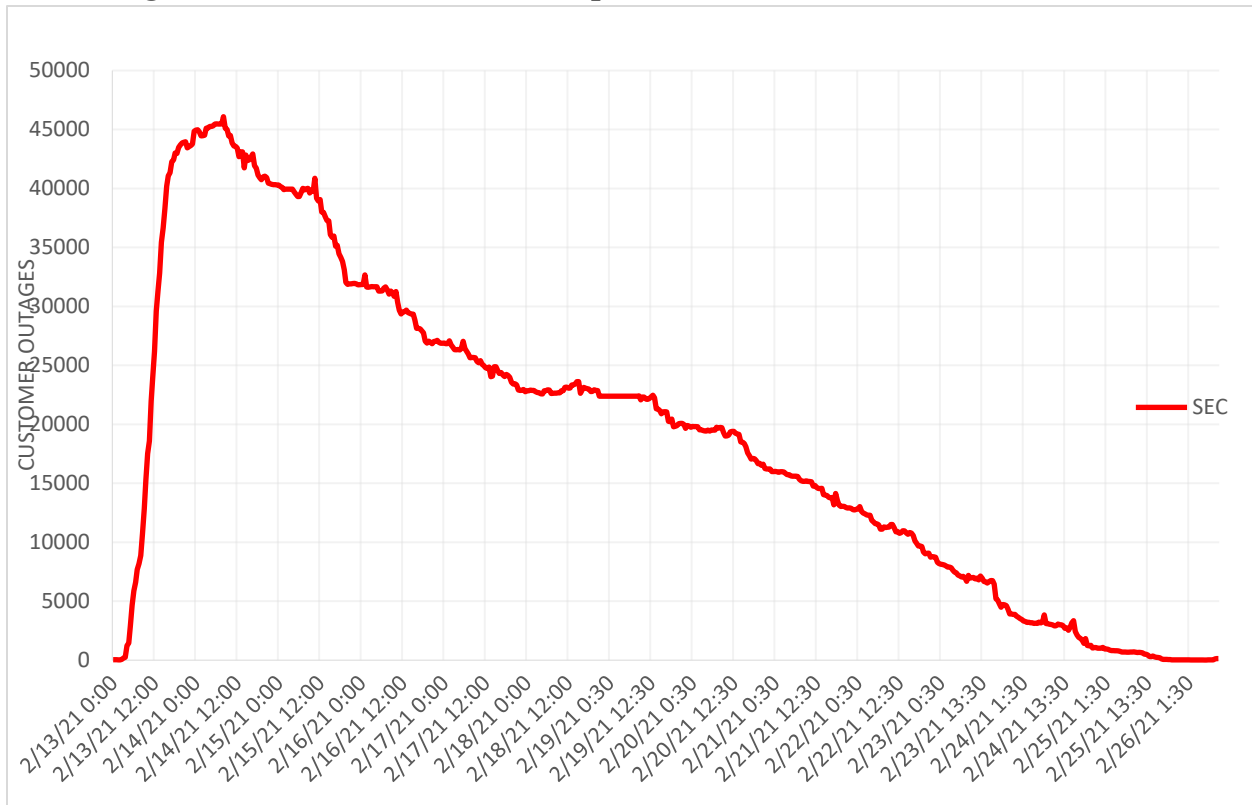
Figure 7. Southside Electric Cooperative Ice Storm Restoration Curve

hours. According to Southside, the first reported storm related outage occurred on February 12, 2021 at 11:00 PM; the final outage restoration was performed on February 26, 2021 at 9:00 AM. The total restoration time was 13.42 days. The graph below presents a restoration curve for SEC subsequent to the Storm. It shows that in the early days of the restoration, larger outages were being cleared but smaller nested outages⁷ were revealed as larger sections of the system were restored. As such, the number of outage events continued to climb as crews discovered more localized damage (manifest in the small upward spikes observed in Figure 7).

SEC executed 2,136 work orders during the storm restoration to address 866 broken poles and 277 broken cross-arms; 486,000 feet of conductor were restrung. Of the total 2,136 outages on its system, Southside attributed 1,544 outages, or 72.3%, to trees. Of those 1,544 tree-related outages, SEC calculated that 1,480, or 95.9%, were attributed to trees located outside the ROW. The high percentage of tree-related outages and the resultant significant distribution infrastructure damage experienced during this Ice Storm is due in part to the densely wooded nature of SEC's service territory.

Staff understands that relocating large numbers of distribution facilities away from such terrain in order to minimize potential tree-caused damage could be very costly. However, Staff recommends that Southside investigate areas of its service territory that are most likely to experience tree-related power outages (e.g. areas with double-sided ROWs⁸) and consider options to address these vulnerable distribution facilities. Such options could include relocating facilities from overhead to underground, widening ROWs, or relocating facilities to less densely wooded locations. Staff also recommends that, where feasible and cost-effective, SEC consider implementing these options when constructing new distribution facilities to make them more resistant to tree-related damage during storms.

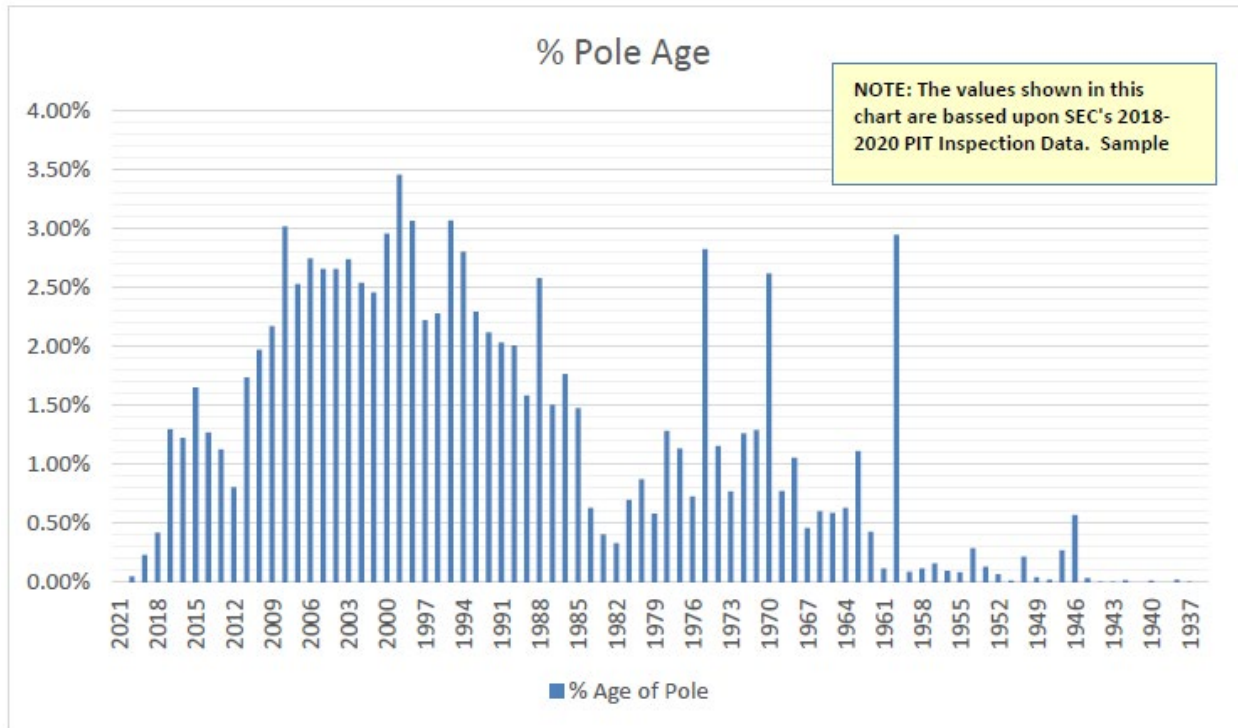
Figure 18. SEC Estimated Distribution Pole Age

its Pole Inspection & Treatment Program. Using this limited data for 2018-2020, SEC extrapolates the age distribution of its approximately 128,000 total pole population as shown below.

Using the same limited data set, the poles that were broken during the Ice Storm are classified by age below. While Staff recognizes that pole age is one of many factors that determine pole condition, Table 21 reveals that 276 poles broken during the Ice Storm were 40-50 years old, and 57 poles were 60-80 years old, indicating that SEC's service territory is characterized by aging infrastructure and reinforcing the need for an accelerated pole inspection and replacement program.
